## Australasian Road Rescue Organisation Inc

## TECHNICAL BULLETIN No. 04/2012

### SUBJECT      *'Vehicle Construction - Fuel Lines'*

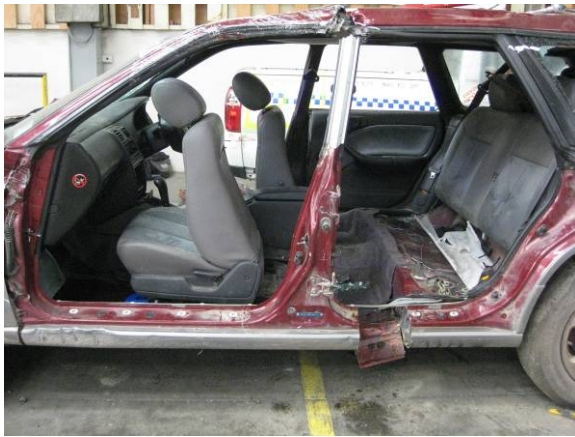
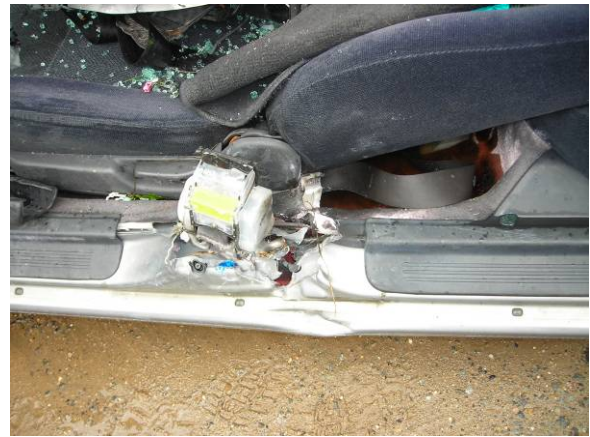
This bulletin highlights a particular construction feature of two (2) particular vehicles; the Subaru Liberty (above) and the Honda Civic.

The routing of fuel lines is very close to the lower B pillar section adjacent to the sill. This area is a location where rescuers may choose to conduct B pillar rip techniques, or to cut and remove the B pillar.

The routing of the fuel lines near the B pillar and close to the sill does present challenges for rescuers. The best defence for rescuers in identifying the location of fuel lines before commencing techniques during extrication is to expose all areas to be cut and identify any potential hazards before cutting; don't rush.

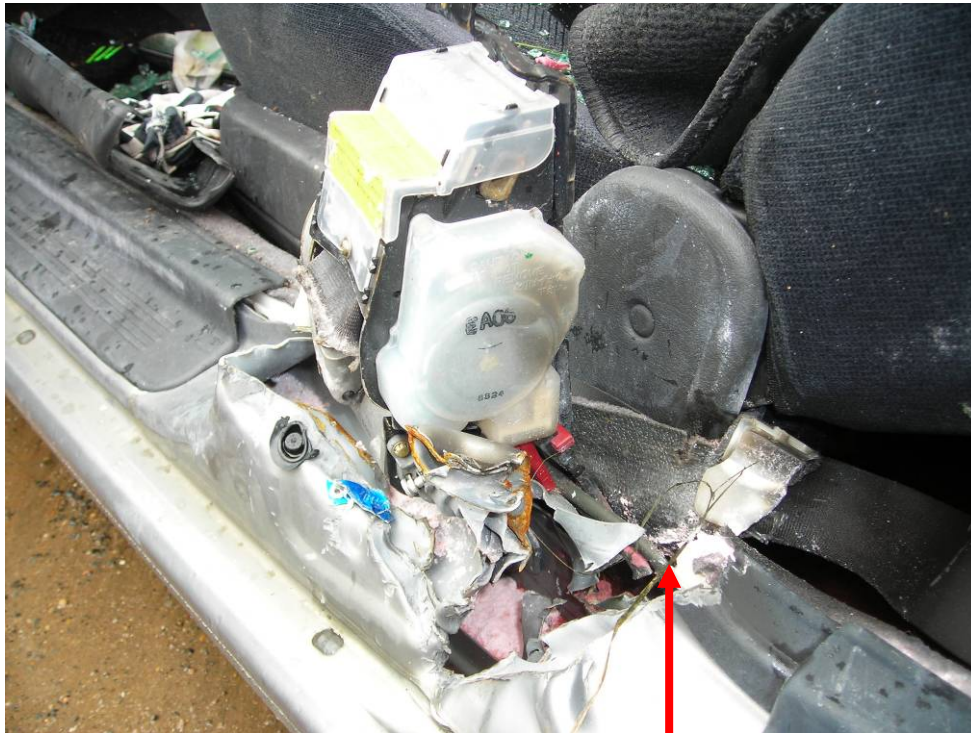
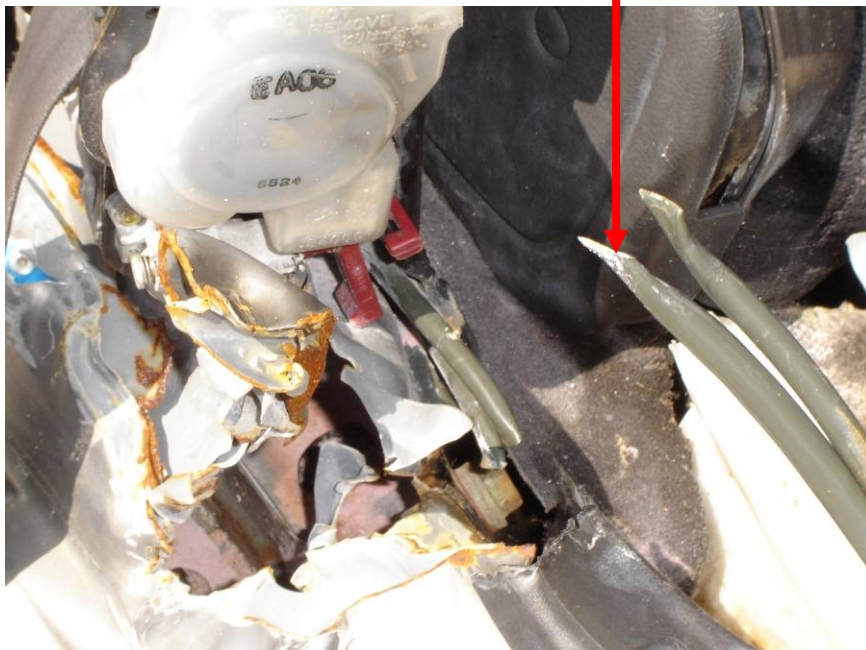
Fuel lines

At an incident involving a 1998 Subaru Liberty wagon, while crews were conducting a B pillar rip, the fuel lines were exposed and cut through inadvertently with the hydraulic shears.

The routing of these fuel lines near the B pillar and close to the sill presented a major hazard for rescuers at the scene as fuel was released into the cabin.

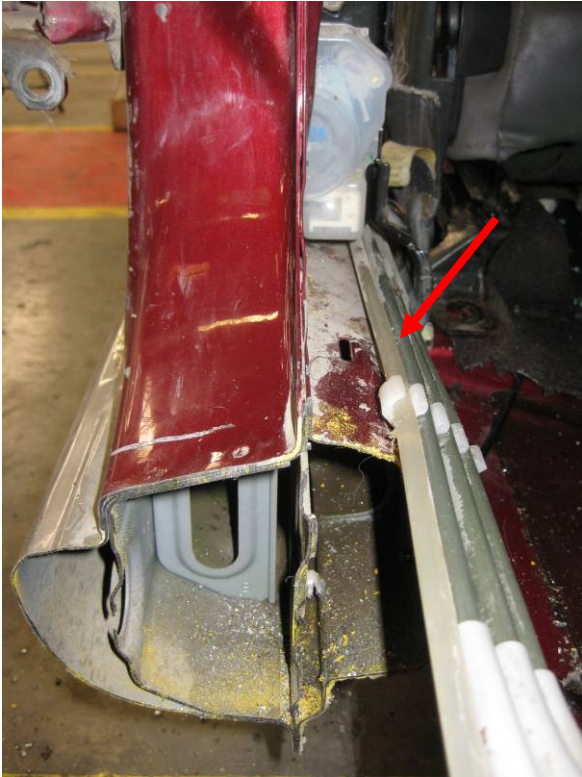
Section of sill removed, looking forward towards the B pillar

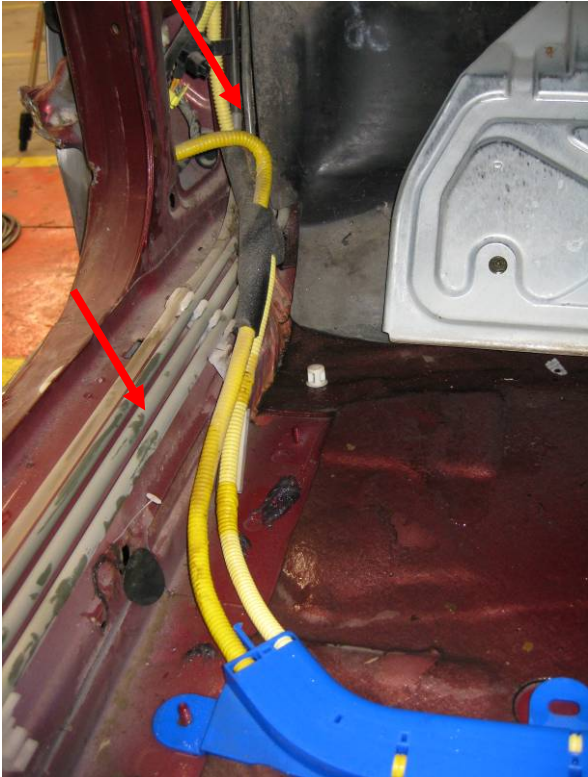
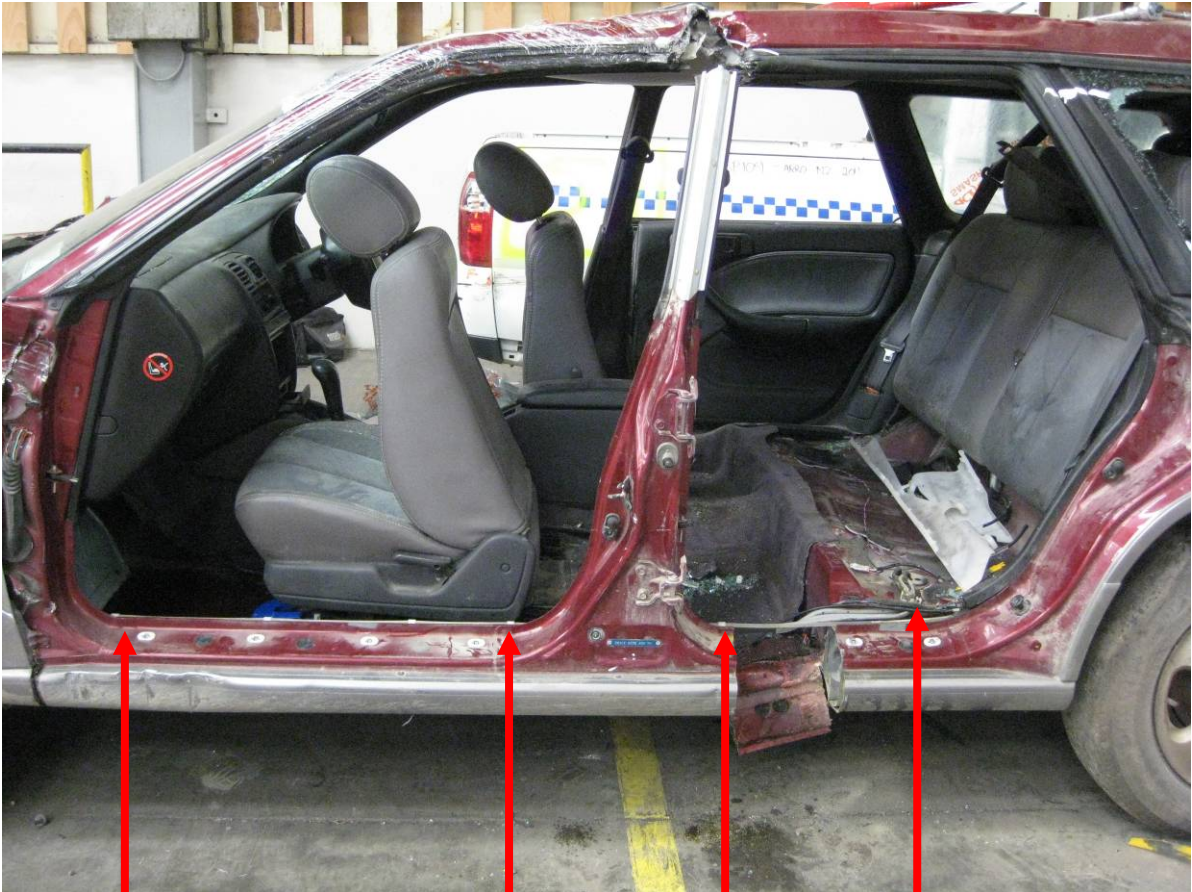
Fuel lines continue up into engine compartment along inner door post (lower A pillar). Note SRS wiring.

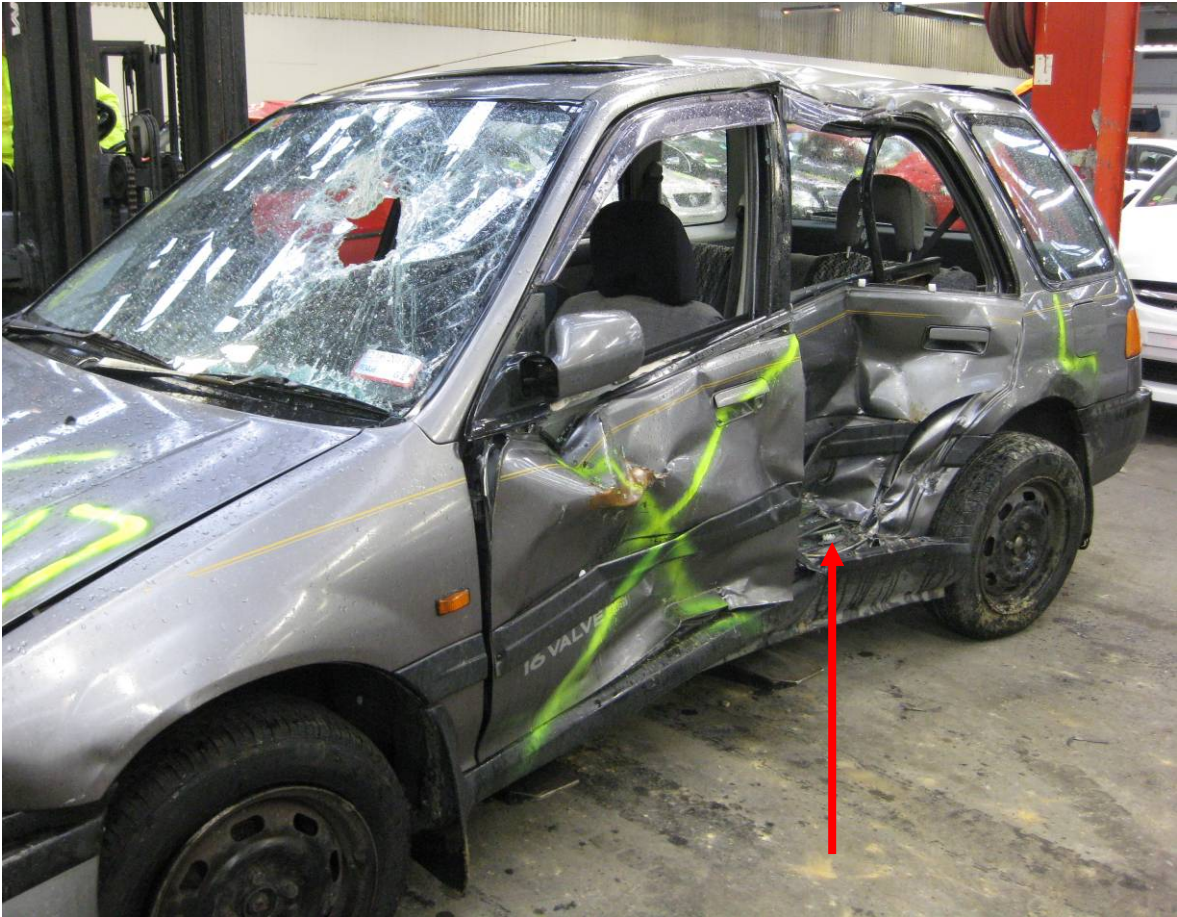
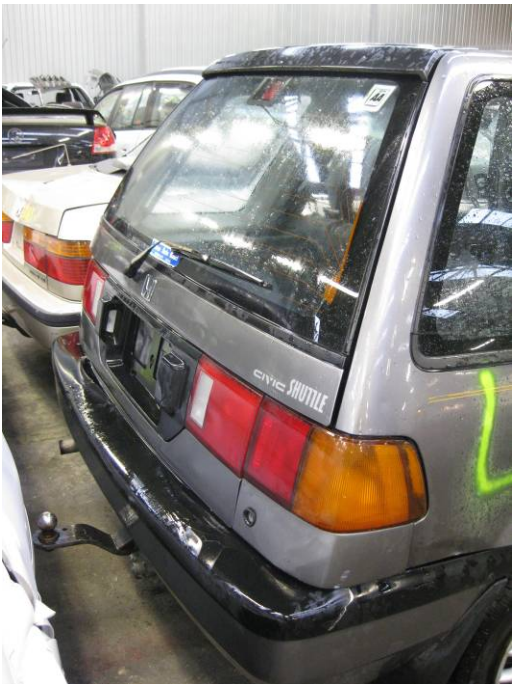
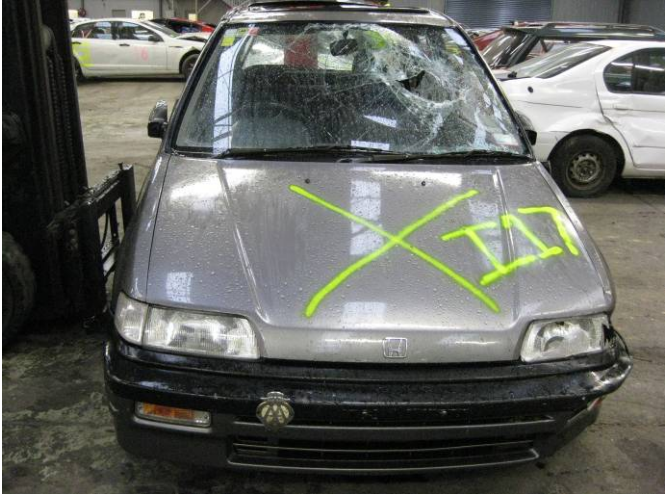
During preparations for the 2011 WRC and ARC held in Wellington, New Zealand, a Honda Civic was identified during preparations as having fuel lines running in a similar location to the Subaru Liberty. The vehicle had been prepared with a simulated side impact collision behind the B pillar.

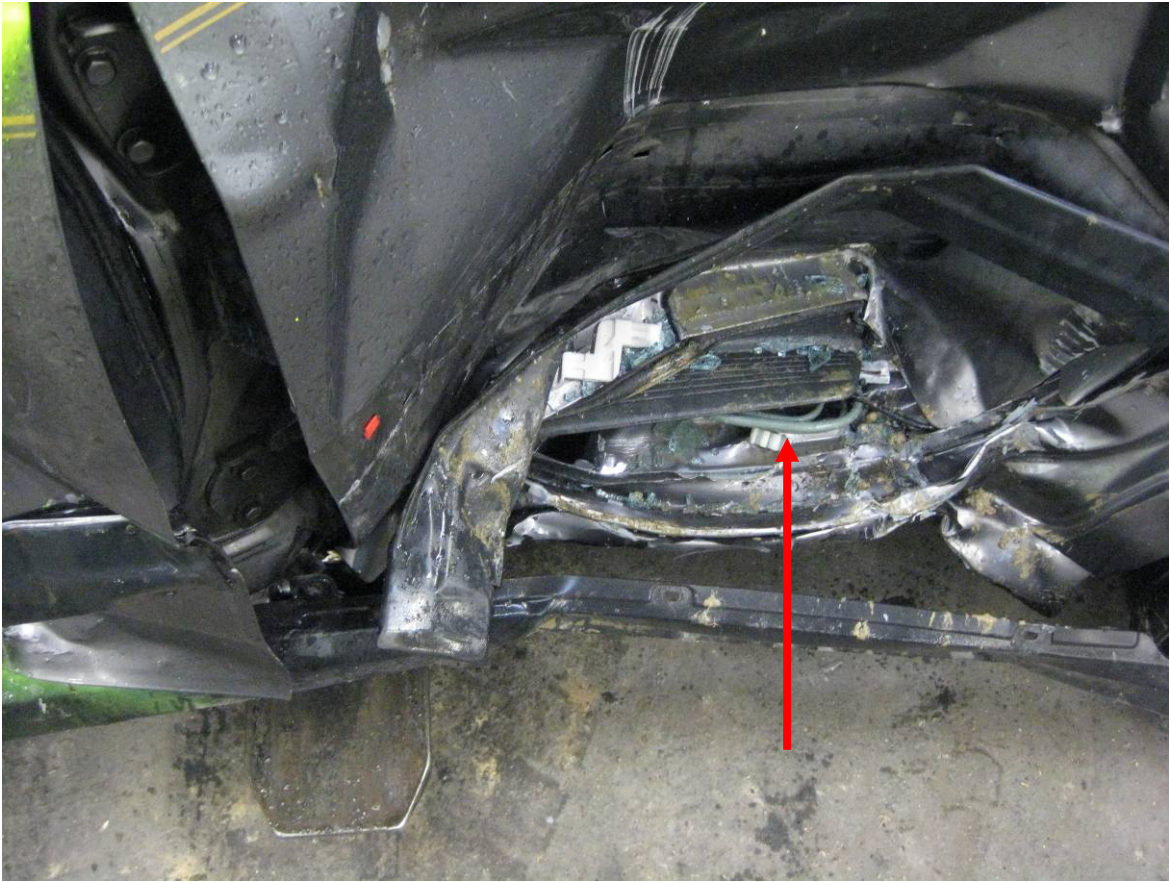
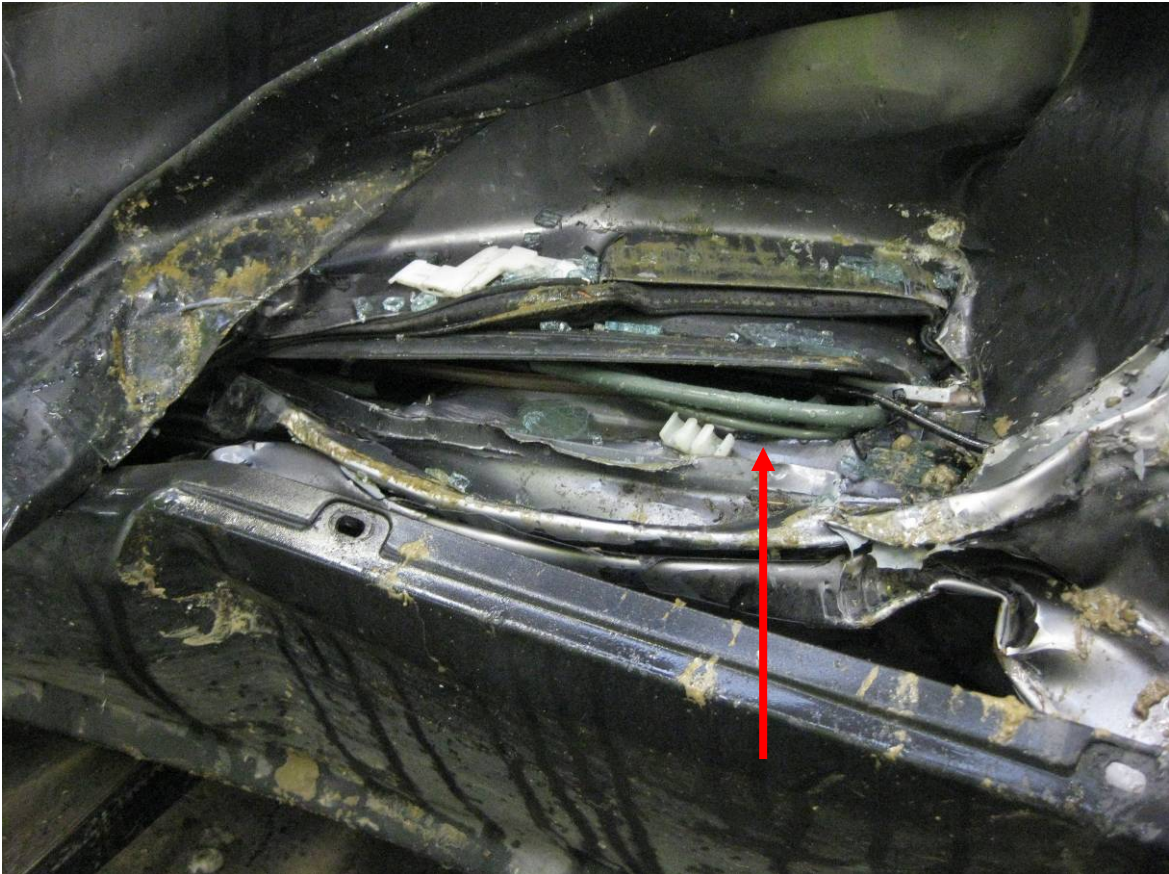
Closer inspection revealed the simulated side impact had exposed the fuel lines running along the inner sill, just behind the B pillar; similar location to the Subaru.

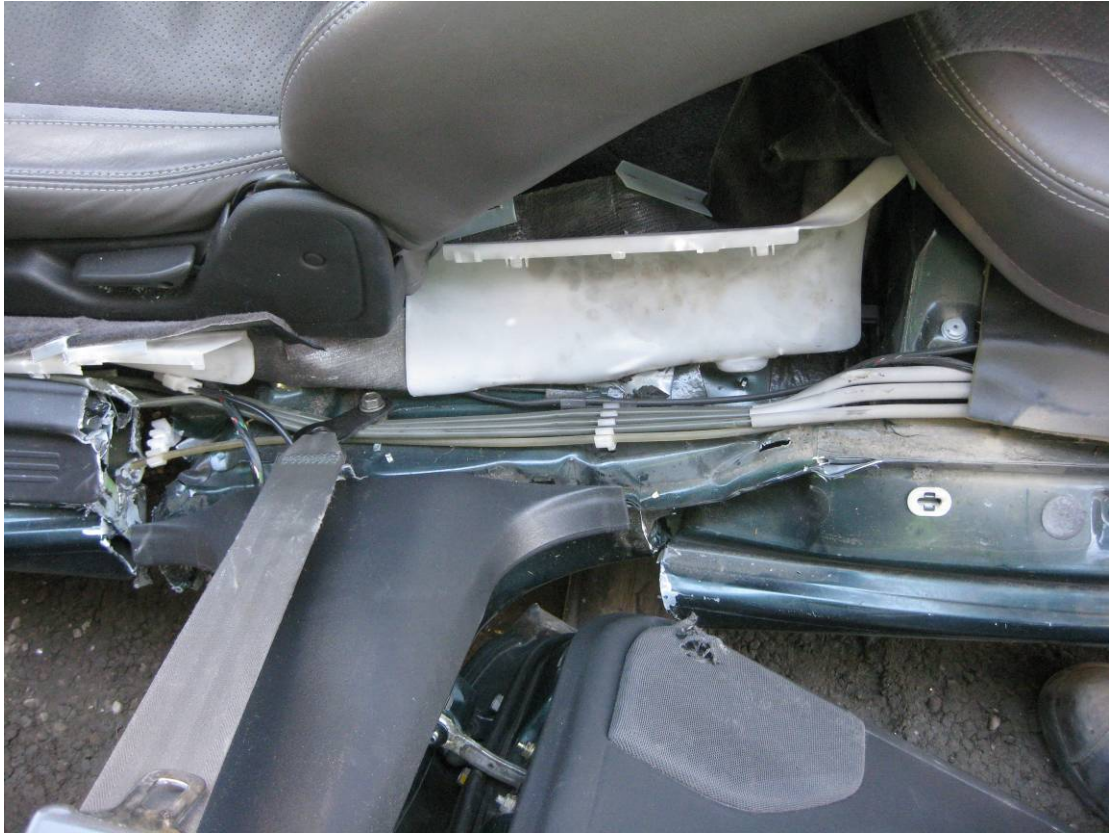
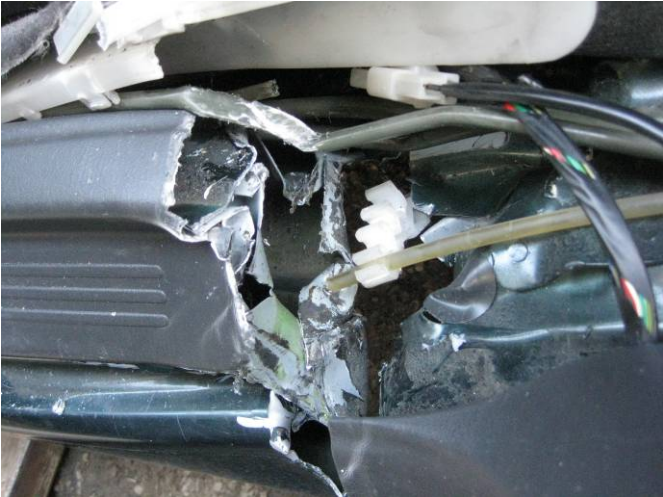
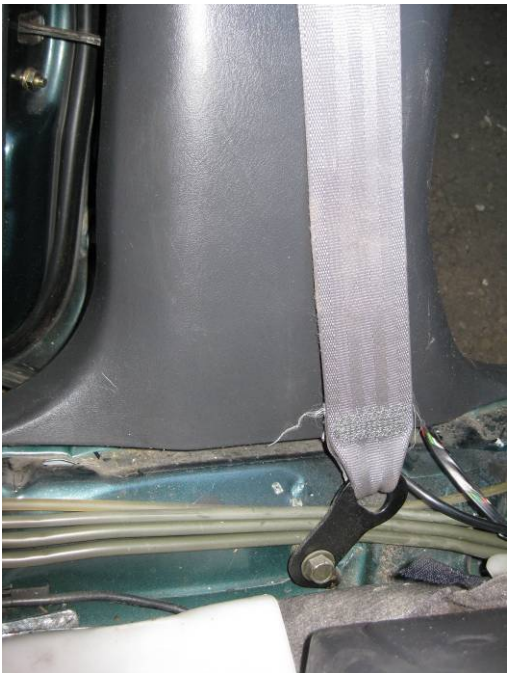
During the 2011 WRC and ARC held in Wellington, New Zealand, a vehicle used in one the scenarios was found to have had the fuel lines cut through as part of team's run in that event. The technique of cutting through the sill each side of the B pillar and then folding the B pillar down is a viable option, however the routing of the fuel lines limited its success, and exposed the casualty, team members and CMT to a fuel leak. Here is a key example that if this can occur during a controlled training event; we all must do more to limit this from happening again.

Agencies should review vehicle construction information contained within training and skills maintenance programs to ensure all personnel are made aware of the various construction variations, and how these may affect extrication options.

Agencies should review procedures used by rescuers to ensure that 'expose before you cut' or similar concepts are embedded into operations so that all hazards at the point of operations can be identified and managed.
