## **TECHNICAL BULLETIN No. 01/2002**

**SUBJECT:** Supplementary Restraint Systems, 1997 Volvo S40 Sedan.

1997 Volvo S40 sedan.

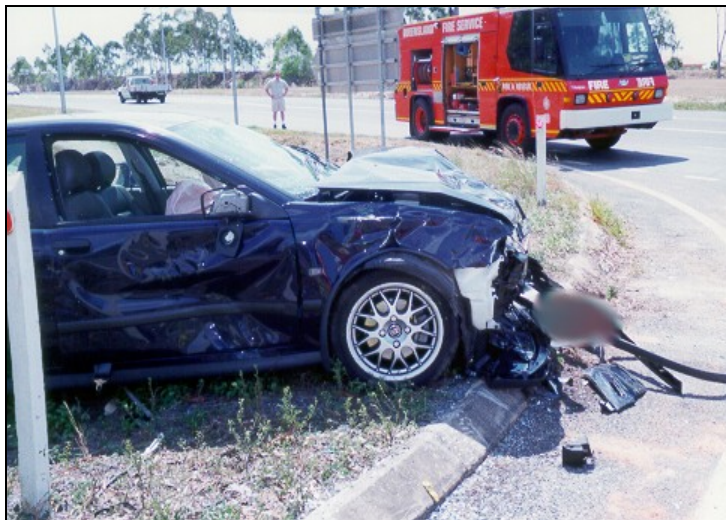
This particular vehicle was fitted with two traditional frontal impact airbags, one mounted in the steering wheel and the other in the passenger dash pad above the glove box (top mount). Both front seat occupants are provided with pre-tensioning seat belts with force limiters, and Side Impact airbags are fitted to the two front seats. A burglar/car alarm was also fitted, this made for an interesting reaction once the battery was isolated.

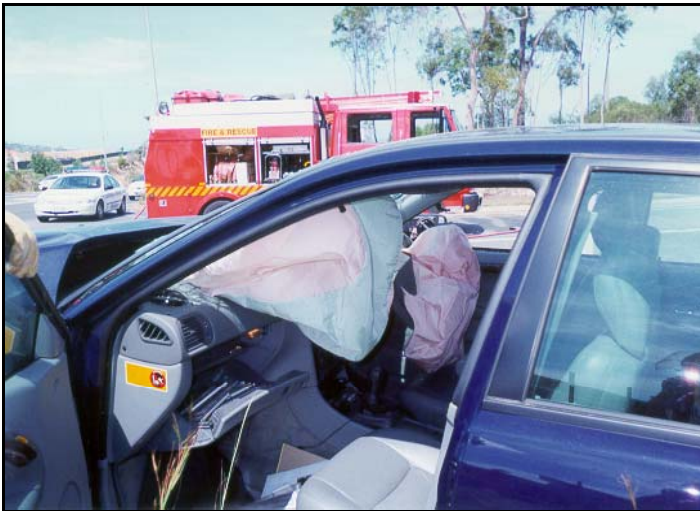
The frontal impact airbags presented no post-accident concern apart from the need to be aware of the by-products of their deployment, and we noted the position they were still in approximately one (1) hour post accident deployment.

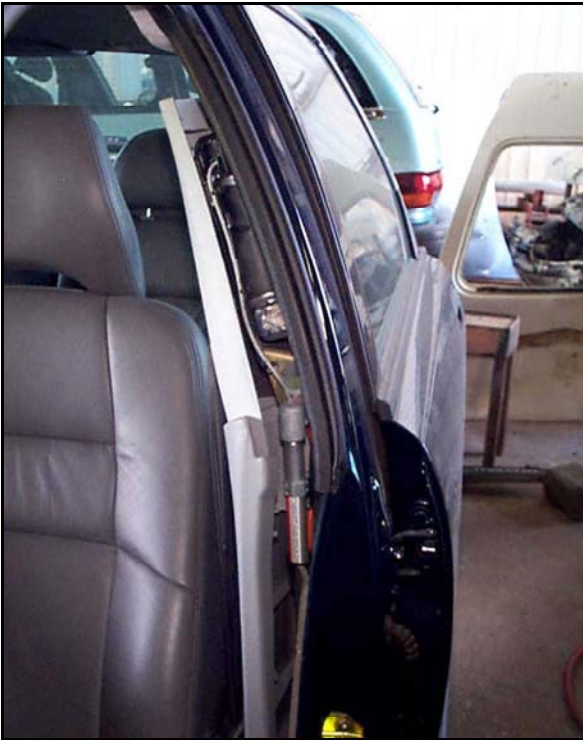
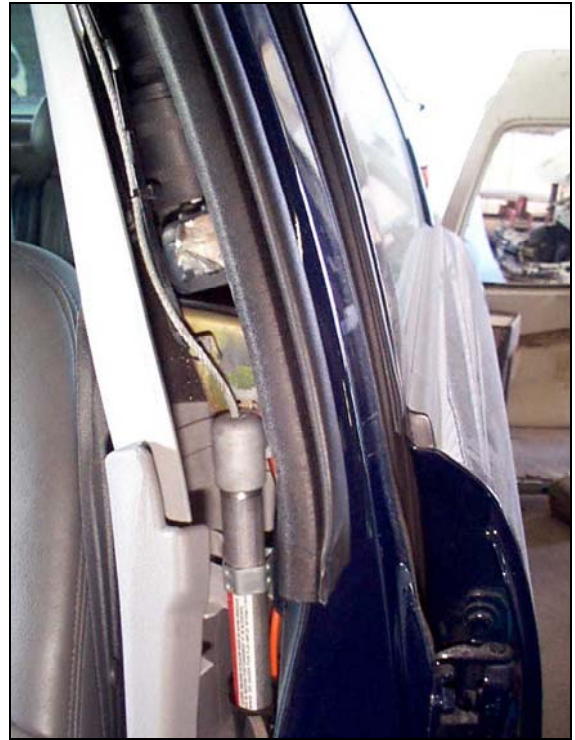
On closer inspection the seat belt assembly is now located considerably higher in the 'B' pillar, this highlights the need to expose the interior trim, before cutting commences. Also you can see the seat belt pre-tensioning mechanism, located below the vertical mounted seat belt reel. The whole assembly is attached with a thick steel bracket. This appears to be a generic design for some models of European motor vehicles.

The location of the steel mounting bracket and pre-tensioning cable will certainly require rescuers to reconsider where the cut is made if the roof is to be released prior to any side removal techniques.

It should be noted that other models of Volvo vehicles are continuing this trend of locating the seat belt and pre-tensioning system higher up than in previous vehicles that we may be used to. If in doubt consult any reference material available or conduct further research.

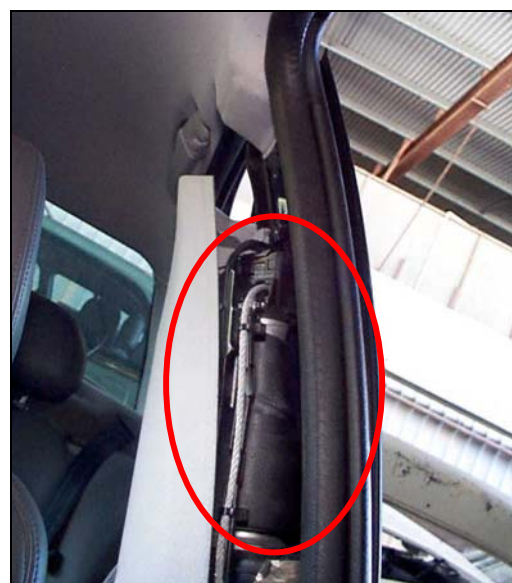
Other likely construction features in the same area include the ergonomic seat belt height adjusters fitted in the majority of newer vehicles we see in Australia.

These are also constructed with a steel bracket attached to the 'B' pillar. This steel bracket allows the upper seat belt point to slide up or down to suit the occupant's height in the seat.

These brackets are mounted in a similar location as the photo, so this area should be avoided when attempting to cut the upper section of the 'B' pillar.

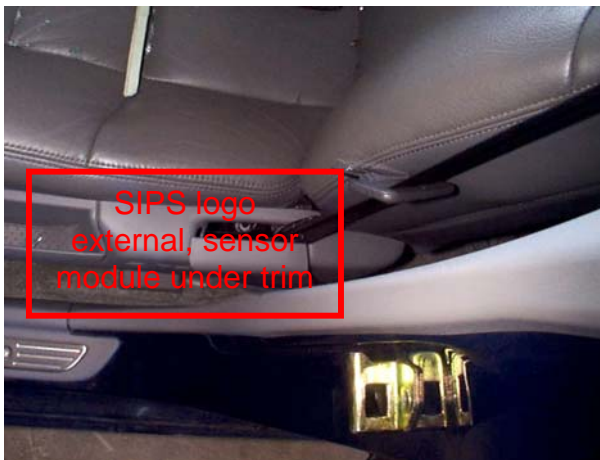
The 1997 Volvo S40 (and some other Volvo models) are fitted with a mechanically activated Side Impact Protection System (SIPS). The airbag sensor module is concealed along the outer bottom edge of the seat. Its location is identified by an engraved 'SIPS' logo in the plastic trim along the seats lower outer edge. The airbag itself is located along the outer upper edge of the seat, beneath the upholstery.

Rescuers should be aware that this side air bag sensor is self contained and mechanically activated, and is not deactivated by battery isolation. Options for protecting the striker pin that completes the circuit may not be suitable in all conditions. Two options identified through various text is to either cut the wire between the sensor and the airbag, and/or fit the red transport lock over the striker pin.

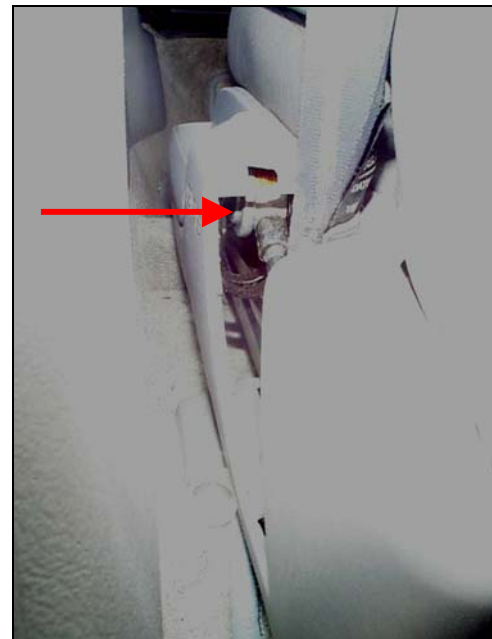
This next photo shows the location of the striker pin looking forward from behind the front seat. This may not always be accessible particularly when the vehicle has been involved in a side impact.
